NATIONAL DAM SAFETY PROGRAM. PINE TREE LAKE EAST DAM (NO 30992)--ETC(U)

REPORT DOCUMENTATION PAGE		READ INSTRUCTIONS BEFORE COMPLETING FORM
1. REPORT NUMBER	2. GOVT ACCESSION NO.	3. RECIPIENT'S CATALOG NUMBER
	AD-A106452	
4. TITLE (and Subtitle) Phase I Dam Inspection Report National Dam Safety Program Pine Tree Lake East Dam (MO 30992) & West Washington County, Missouri (MO 30995)		5. TYPE OF REPORT & PERIOD COVERED Final Report

PINE TREE LAKE EAST DAM

OVERVIEW
PINE TREE LAKE WEST DAM

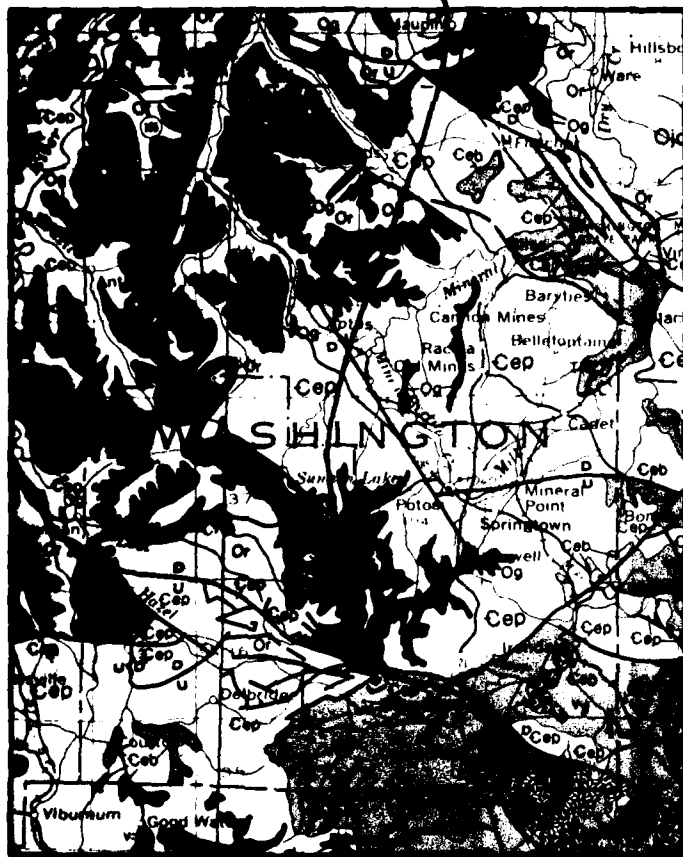
Fig. 4

The dam site is located on the northern flank of the Ozark structural dome. The bedrock in the area is mapped as Ordovician age Gasconade Formation on the Geologic Map of Missouri (Fig 4). The Gasconade Formation is predominantly a cherty dolomite which varies from coarsely crystalline and very cherty at the top to finely crystalline with relatively small amounts of chert near the bottom of the formation. Caves and springs are common in this formation in the central Ozarks, but the field inspection did not identify any evidence of solution activity in the vicinity of the subject dam.

Three faults or fault zones are mapped within 5 mi of the dam (Fig 4). The Shirley Fault Zone is mapped as approximately 8 mi in length, terminating less than 0.5 mi west of the dam. This fault is mapped as northeast side up. The Palmer Fault Zone, a complex network of short and long faults approximately 34 mi long is located approximately 5 mi south of the dam. The fault is mapped as down to the north. The Aptus Fault is located approximately 4 mi northeast of the dam. This fault has a mapped length of approximately 15 mi and is mapped as up to the northwest.

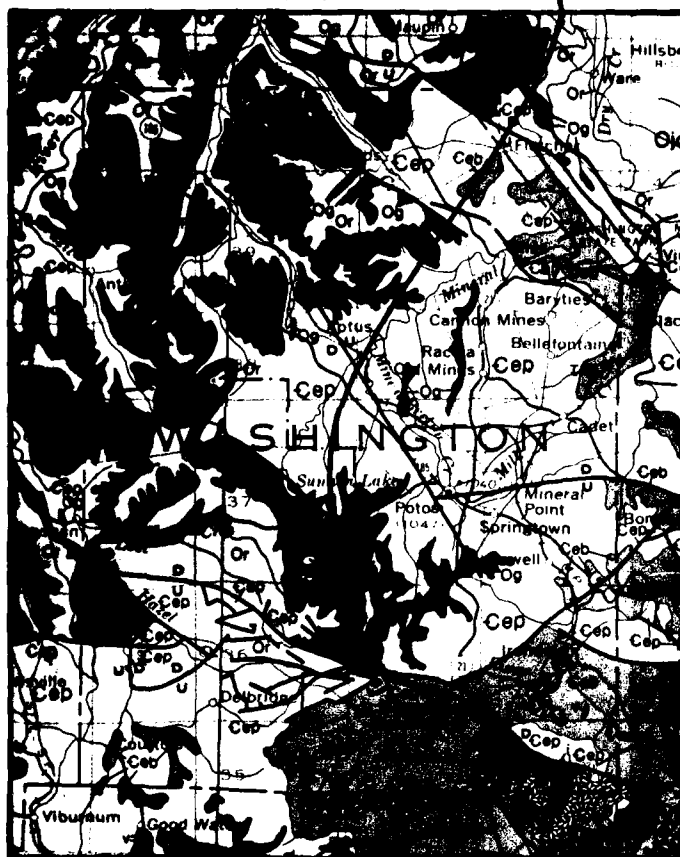
Fig. 4

The dam site is located on the northern flank of the Ozark structural dome. The bedrock in the area is mapped as Ordovician age Gasconade Formation on the Geologic Map of Missouri (Fig 4). The Gasconade Formation is predominantly a cherty dolomite which varies from coarsely crystalline and very cherty at the top to finely crystalline with relatively small amounts of chert near the bottom of the formation. Caves and springs are common in this formation in the central Ozarks, but the field inspection did not identify any evidence of solution activity in the vicinity of the dam.

Three faults or fault zones are mapped within 5 mi of the dam (Fig 4). The Shirley Fault Zone is mapped as approximately 8 mi in length, terminating less than 0.5 mi west of the dam. This fault is mapped as northeast side up. The Palmer Fault Zone, a complex network of short and long faults approximately 34 mi long is located approximately 5 mi south of the dam. The fault is mapped as down to the north. The Aptus Fault is located approximately 4 mi northeast of the dam. This fault has a mapped length of approximately 15 mi and is mapped as up to the northwest.
